## PROPERTY INSPECTION REPORT

**Concerning:** 123 Your Street, Any Town, Texas  
(Address or Other Identification of Inspected Property)

**By:** Jim Luttrall #3779 6/2/06  
(Name and License Number of Inspector) (Date)

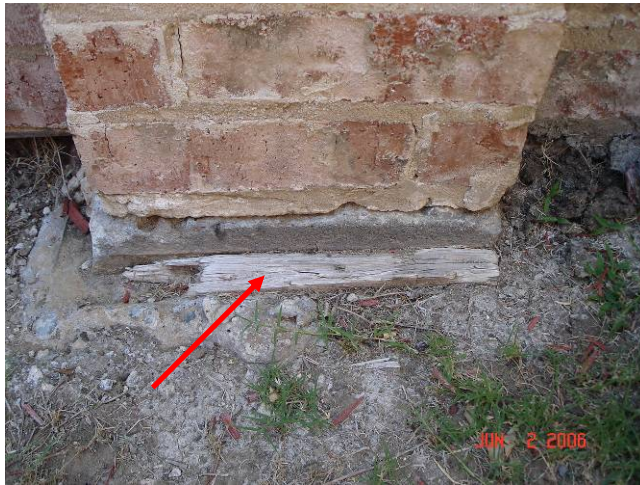
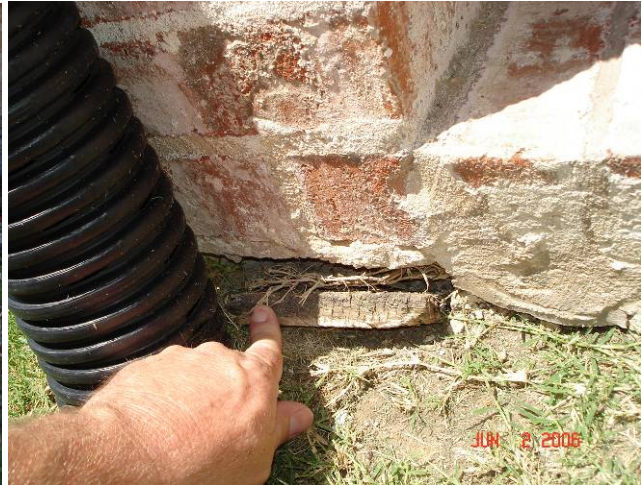
There are minor amounts of wood and construction debris at the base of the courtyard wall and various other locations around the house which should be removed to lessen the risk of attracting wood destroying insects.

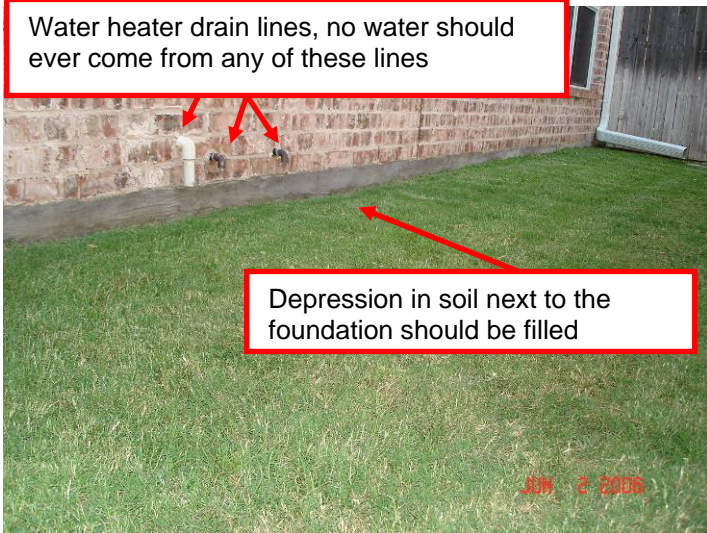
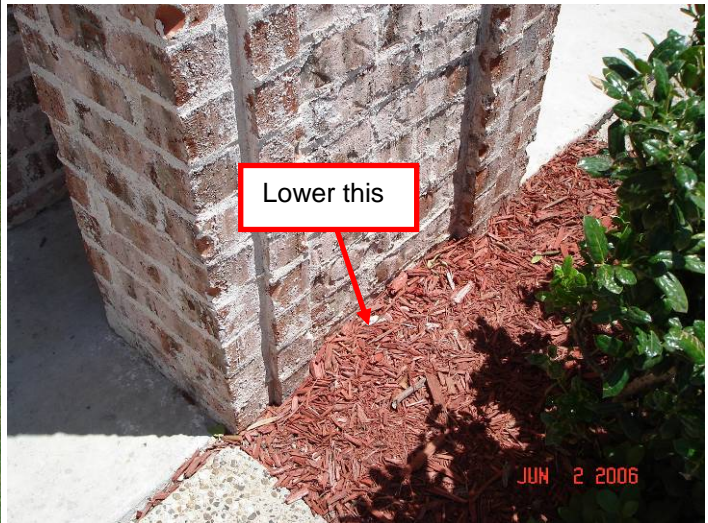
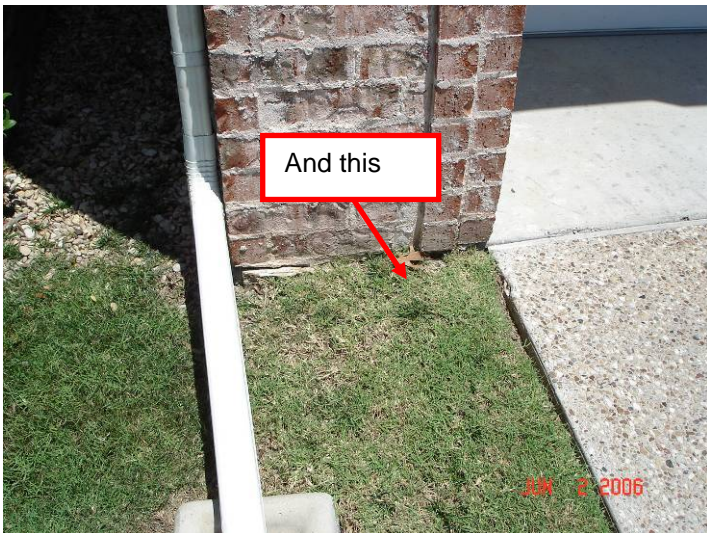
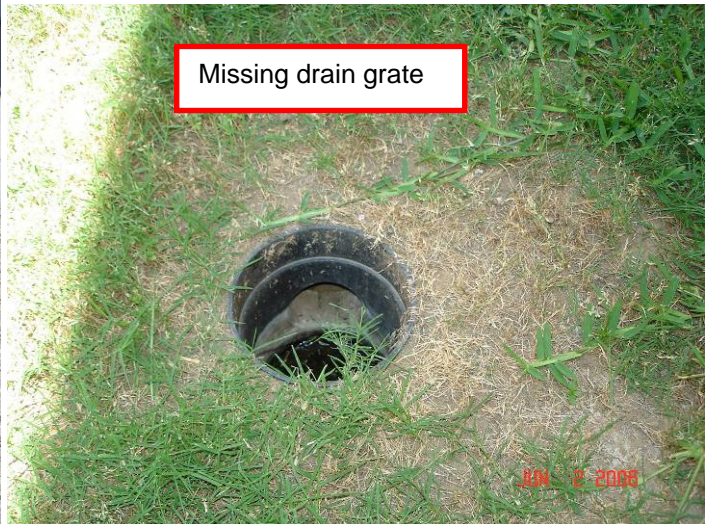
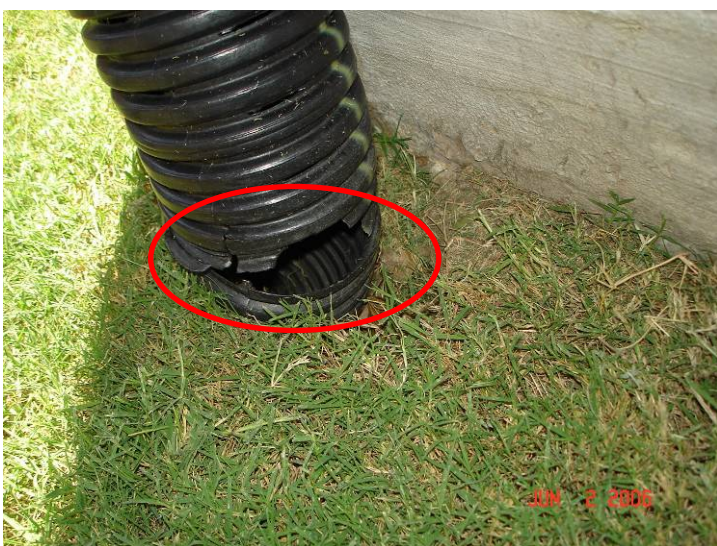
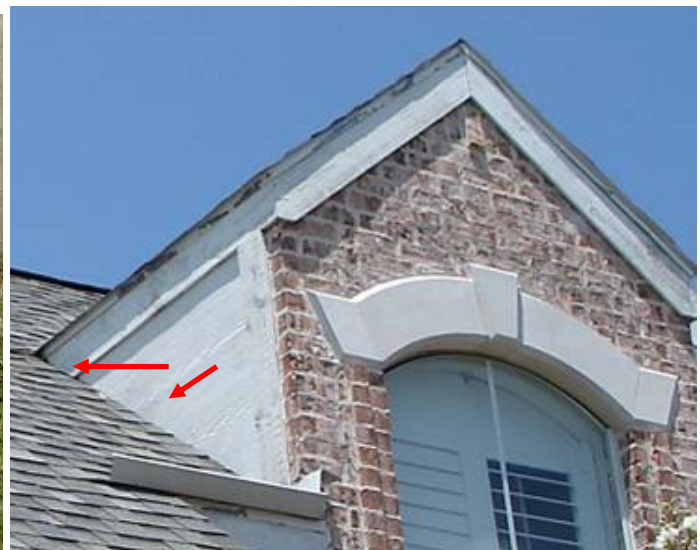
The grading should be improved at the rear of the house to promote the flow of storm water away from the house. This can usually be accomplished by the addition of top soil. The ground should slope away from the house at a rate of one inch per foot for at least the first ten feet. Ideally, at least two (2) inches of clearance should be maintained between soil level and the bottom of brick walls. No water should ever be allowed to stand or run next to the foundation.

The mulch and soil at the front column and façade should be lowered to expose the foundation and provide an inspection zone below the brick for the detection of wood destroying insects.

There is a missing drainage grate in the landscape drainage system in the courtyard which should be replaced to prevent entry of foreign objects as well as reducing trip hazards.

The rain gutter downspout extension should be repaired at the south east corner of the house.

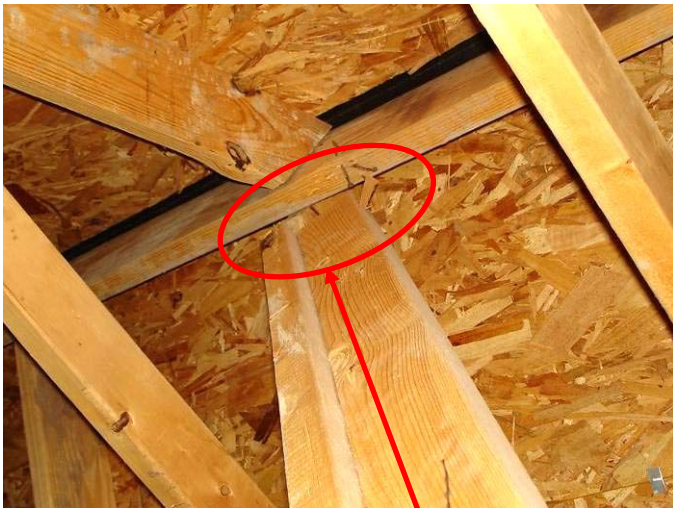
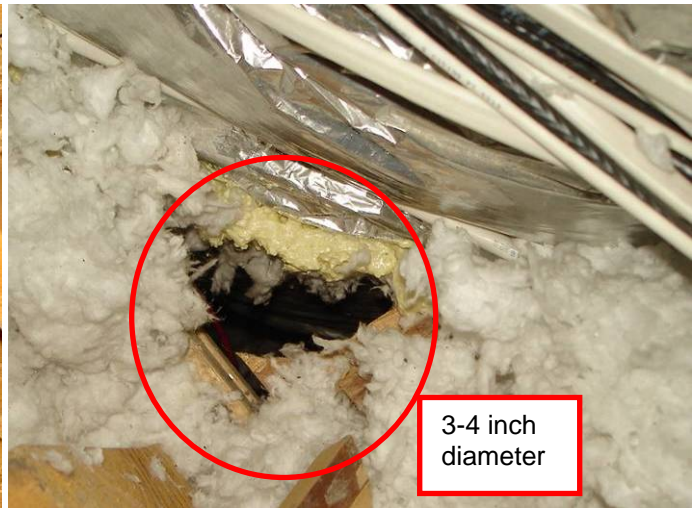
There is a loose brace to the south ridge board which should be reattached.

There is a minor opening at the duct chase leaving the attic which should be sealed to prevent air/heat leakage.

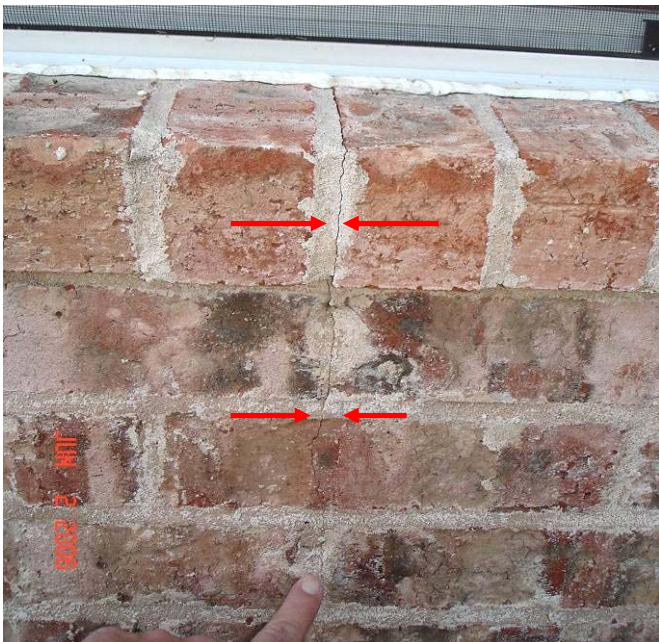
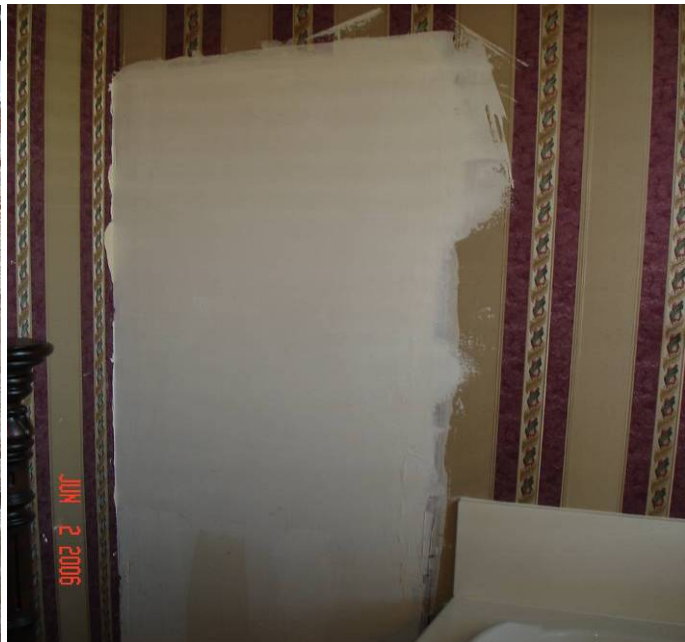
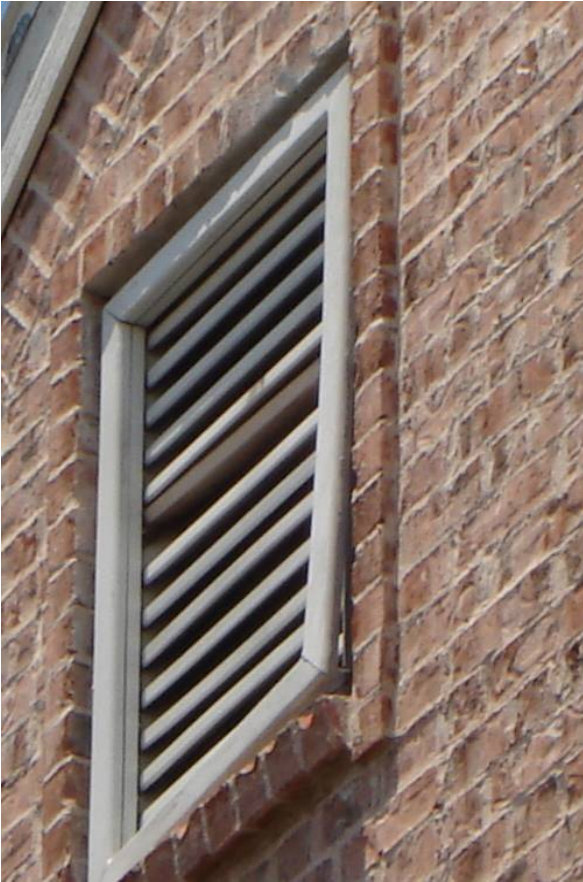
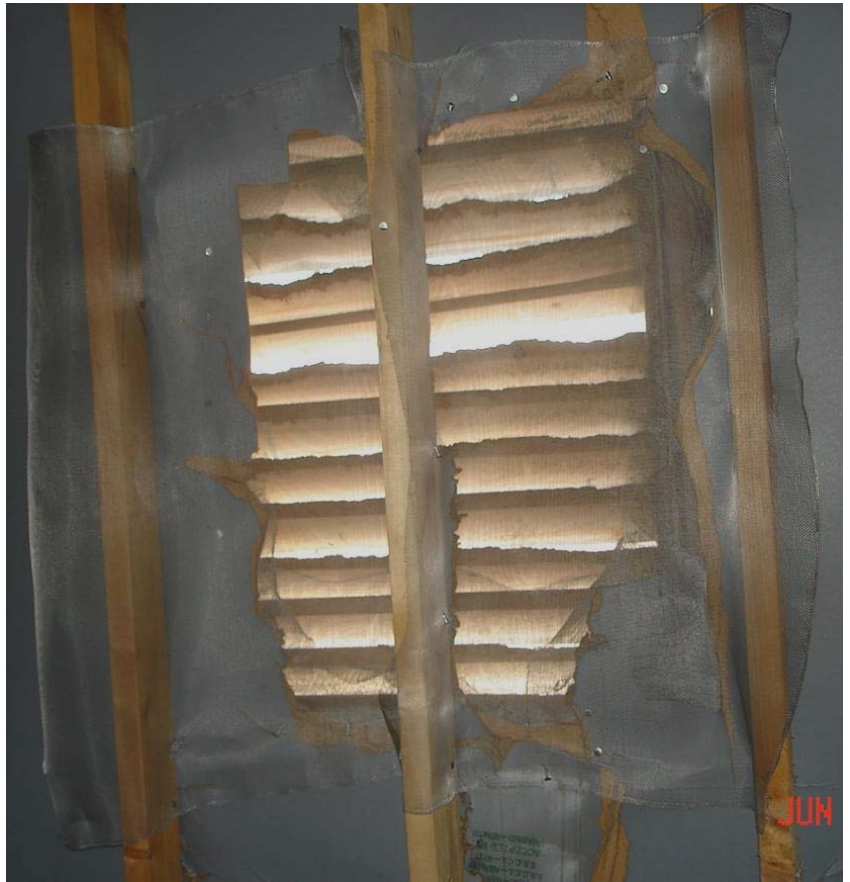
Evidence of patching was detected at the downstairs full bath. A door appears to have been removed and is partially finished, cosmetic issues only.

Typical minor cracking was observed on the exterior walls of the house below the east window.

The south gable vent is damaged and should be repaired.

Caulking and painting of exterior is recommended in the near future.

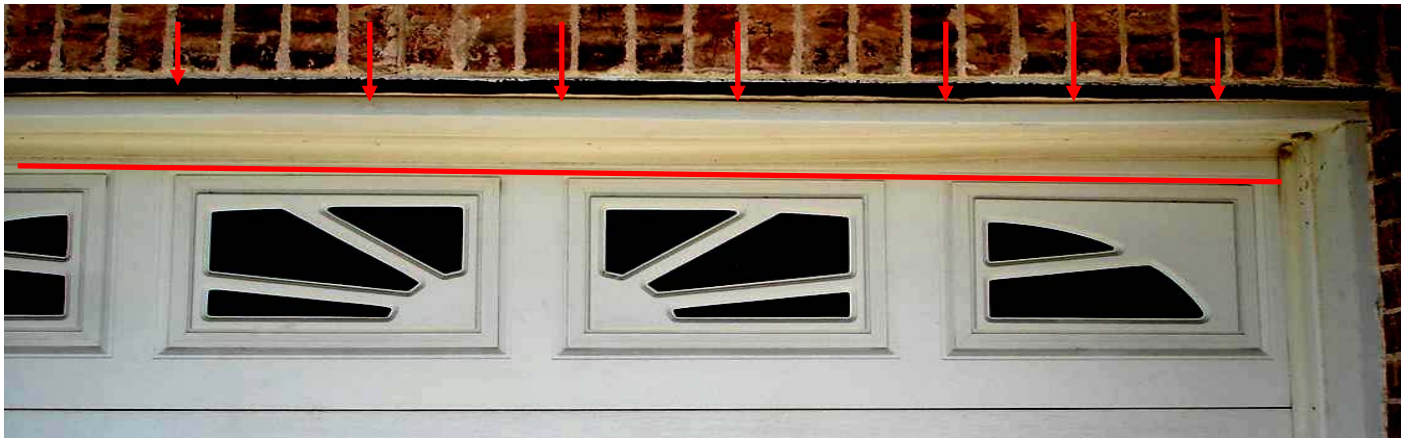
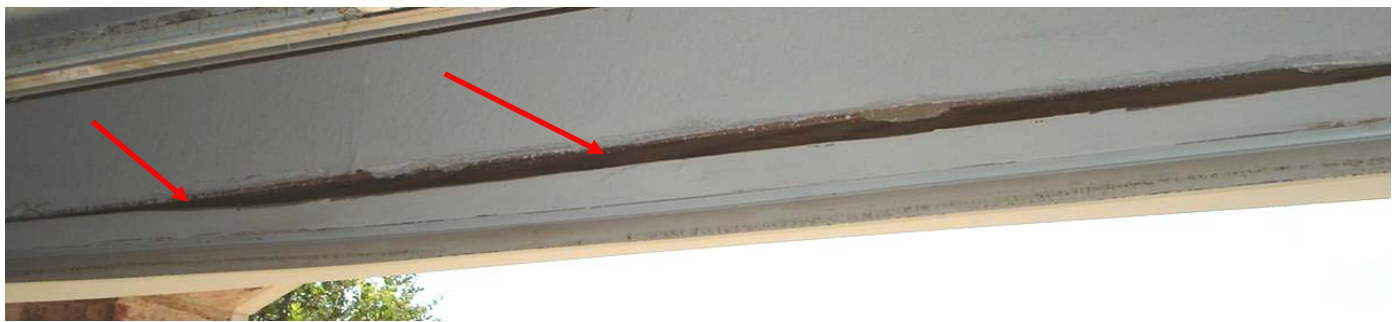
The north garage door frame (trim board) is warped and gapped open on the garage side. While this is not a load bearing board, replacement is advised.

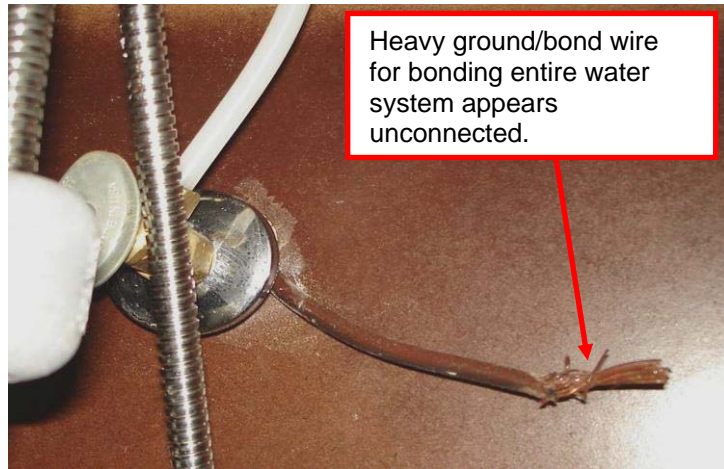
It appears the grounding/bonding clamp is missing at the kitchen sink. This should be investigated and repaired as may be needed by a qualified electrician. Bonding of metal gas pipe should also be investigated.  
The dead front on the breaker panel is secured with some non-approved sharp screws rather than the proper blunt end screws. Replacement is recommended to protect personnel.

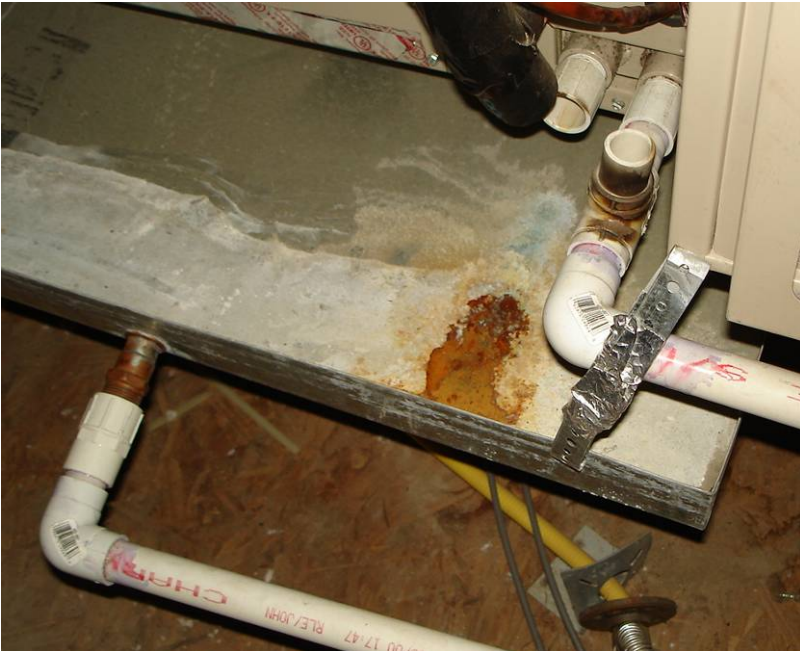
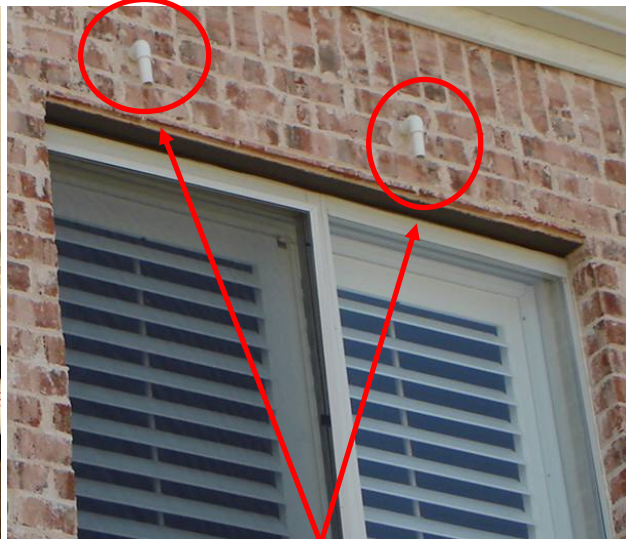
*Comments:* Minor rust in secondary drain pan. Monitor and provide annual service for the systems.

Monitor – no water should every come from these

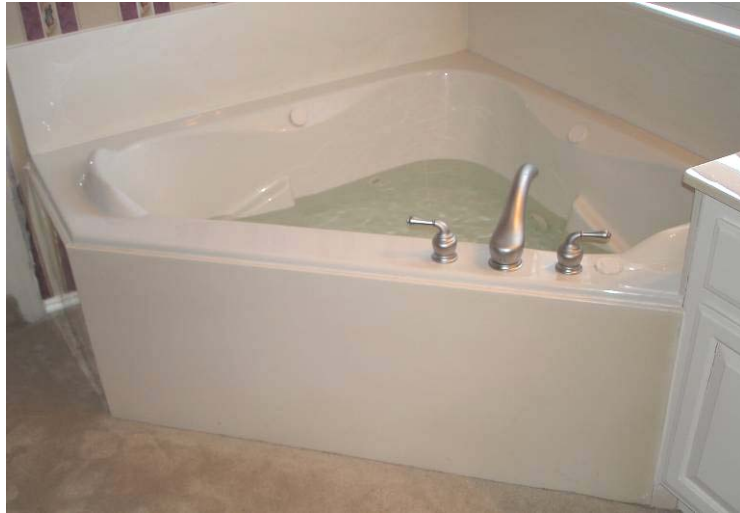
There is no motor access panel provided for tub. The finished surface of the tub skirt will have to be disturbed (cut) if the motor area is to be accessed.

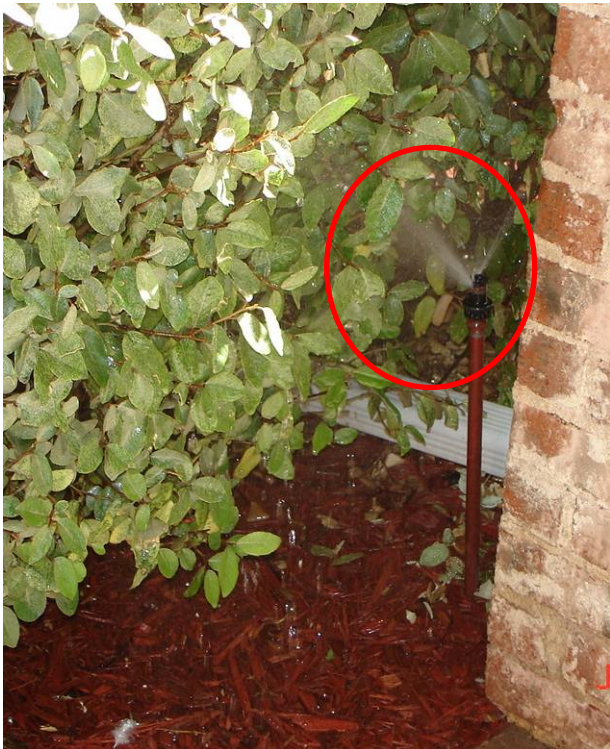
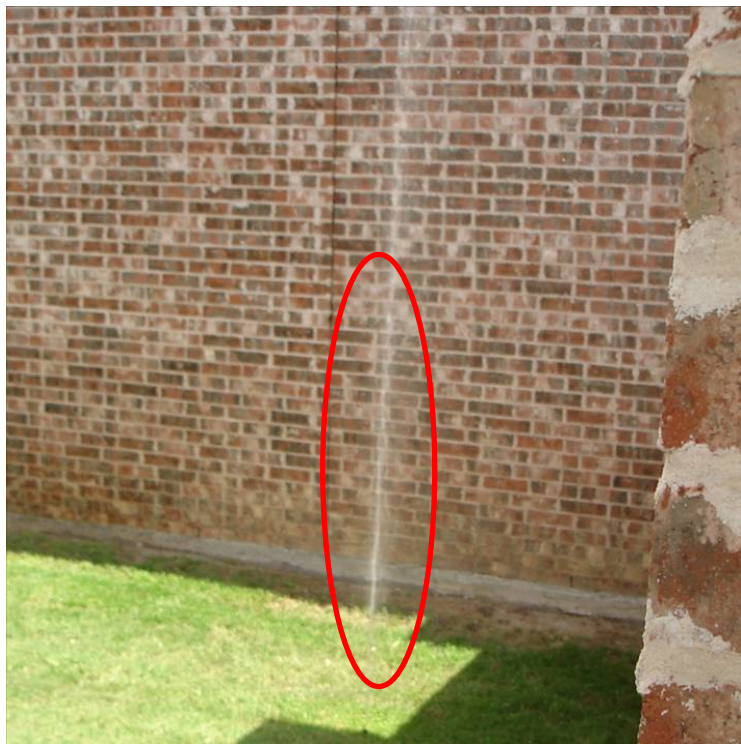
- A. Lawn Sprinklers**  
*Comments:* The courtyard lawn zone showed a broken head (geyser effect) and several of the heads need to be adjusted and/or replaced for proper coverage. All of the fixed risers at the shrubs appear too short for the current height of shrubs. *It is recommended that the entire perimeter of the foundation be water consistently; cooperation and coordination with the neighbors is needed since you water one side of your neighbors' foundation and vice versa.*
